Inspection Report

PRECISE Home Inspections
Tim Larkins
Tennessee Home Inspector License #384
1801 Ridgefield Way
Dalton, GA 30720
(706) 483-3510

INSPECTED PROPERTY ADDRESS:
10 HAPPY WAY
HOMETOWN GA 12345

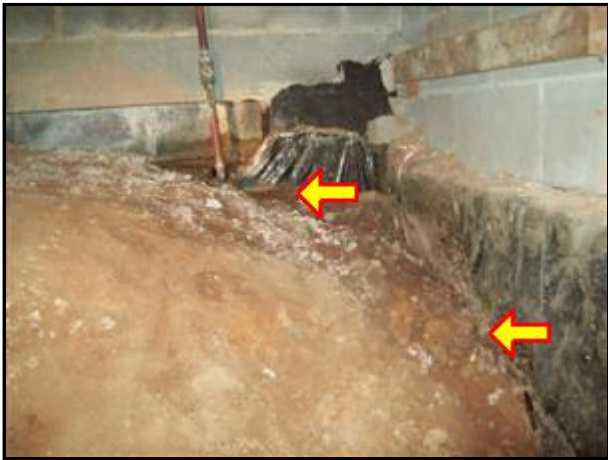
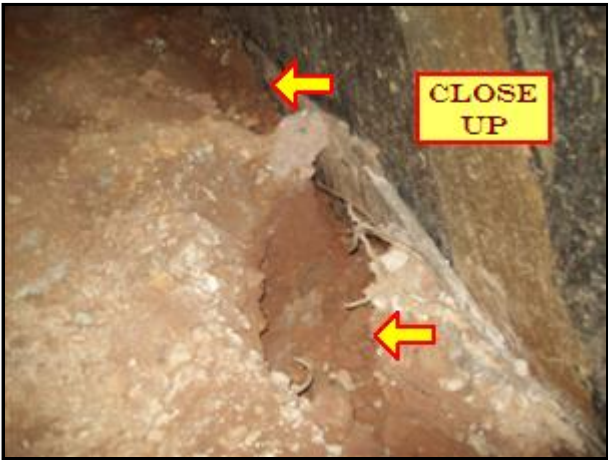
(Picture 1)(Picture 2) **EM** - *crawlspace, front and back wall* - There is evidence of water intrusion at some point. The soil has erosion trenches where it has traveled by basement wall. The amount and circumstances of the intrusion is unknown. Many homes have minor water intrusion with no further problems, while others do have problems. Water in general around the foundation walls and in a crawlspace is non-desirable. Recommend monitoring during a rain storm and correcting as needed.

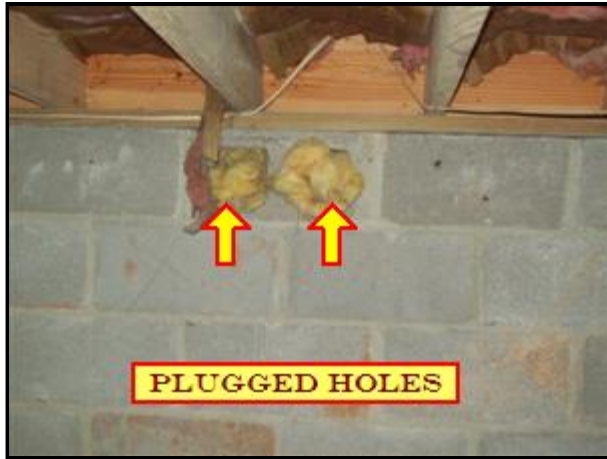
1.3 Picture 1

(Picture 1) **FYI** - *front of home* - One or more of the crawlspace vents have been closed off with some material (socks, insulation, rags, etc..). Crawlspace need to breath, so this should be removed and a proper operable vent installed. Recommend correcting as needed and desired.

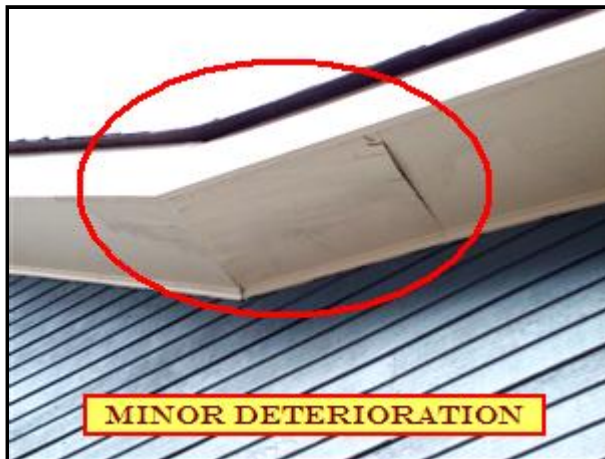
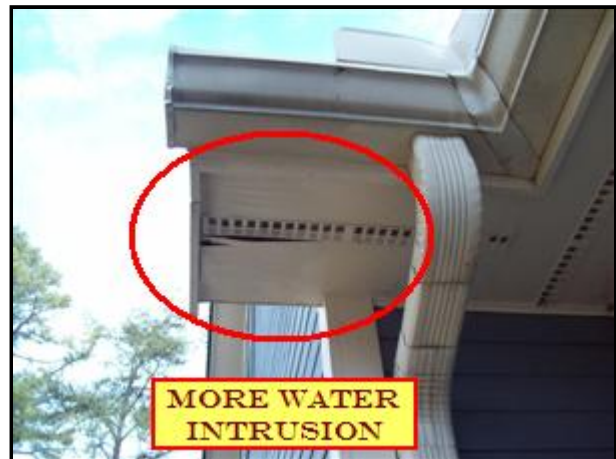
(Picture 1)(Picture 2) **NM** - *front & rear of home* - There is some deterioration of the soffit panel due to moisture intrusion at joints. Deterioration will continue to worsen until sealed properly with a waterproof material. The material is not damaged to the point of needing replacement. Recommend patching and painting as needed.

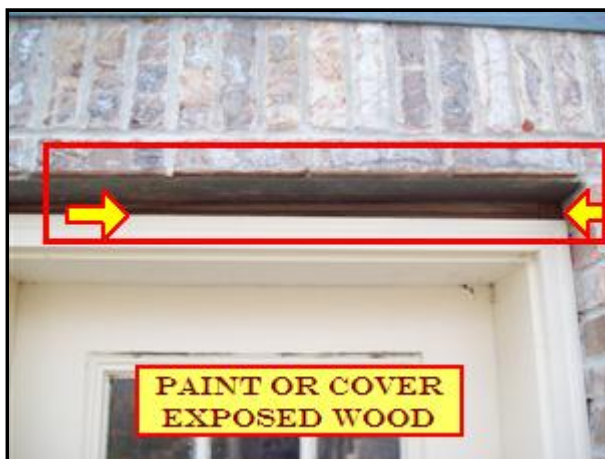
2.2 Picture 1

(2) (Picture 1) **EM** - *right side of home* - The door to garage has exposed non-treated lumber. Keeping this area caulked will prevent water from penetrating the wood and causing premature rot and deterioration. Recommend caulking or sealing gaps as desired with appropriate materials.

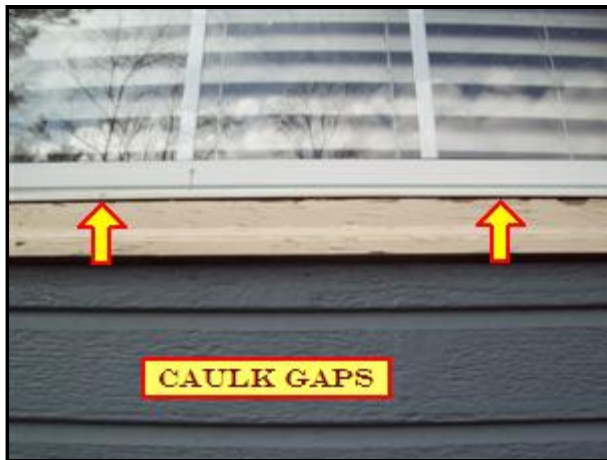
2.3 Picture 1

(Picture 1) **NM** - *Most every window around home* - The windows have not been sealed in some time allowing water intrusion of the wood. The rot or deterioration is minor at this point. Recommend sealing all gaps where windows, trim and siding meet and touching up paint as needed.

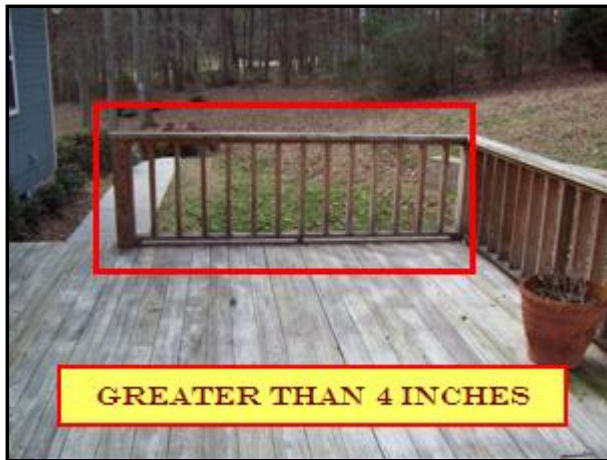
2.5 Picture 1

(Picture 1) **EM** - *rear of the home* - The spindles for the handrail are spaced greater than 4 inches (current requirement). This is ok for this home due to the age and the different construction practices. 4 inches was implemented to prevent children from sticking their heads through. Recommend correcting as desired.

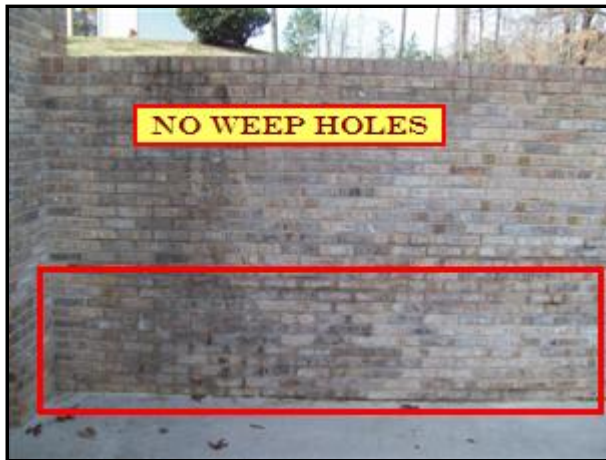
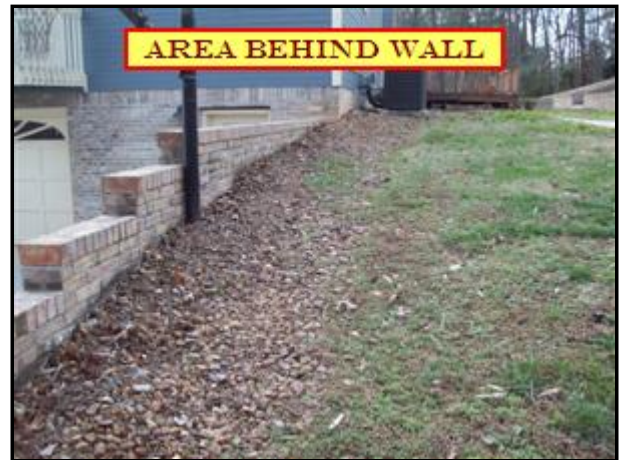
(Picture 1)(Picture 2) **EM** - *right side of home* - The retaining wall is 6 feet high or taller. Common construction practices at this height usually have weep holes. Weep holes allow water or moisture to pass through the wall removing excess buildup. Recommend adding weep holes as needed and desired.

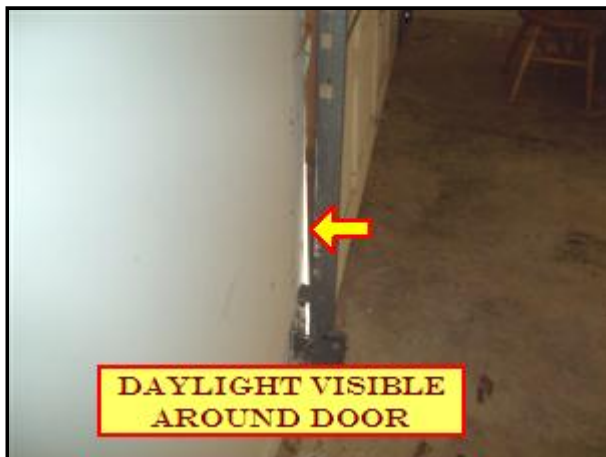
2.13 Picture 1

(2) (Picture 1) **EM** - *right side of home* - The weather stripping around door and at bottom is either not installed or deteriorated. This can allow air and water transfer to the garage area. Recommend repair/install as needed and desired.

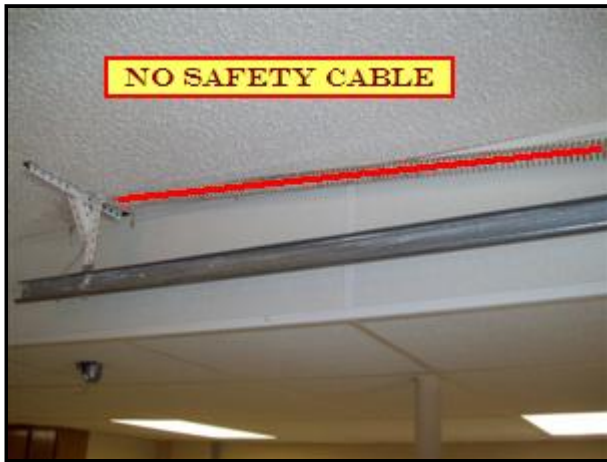
2.13 Picture 2

(3) (Picture 2) **EM** - *garage , right side of home* - The safety cables for springs are not installed. This is a small repair that costs little money and time to correct. Recommend correcting as needed and desired.

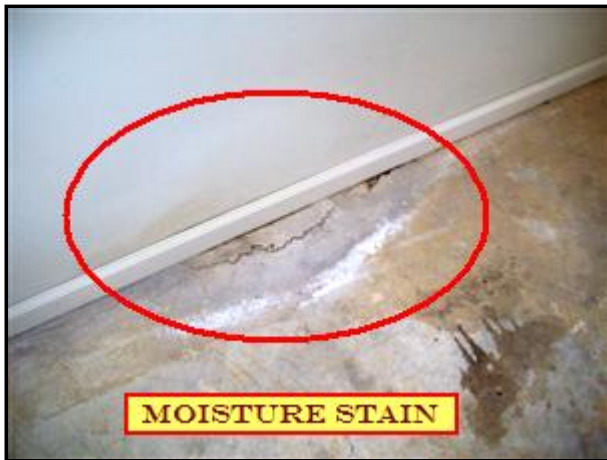
2.15 Picture 1

(Picture 1) **CA - Repair** - rear wall - There was one or more stains at the corner of the wall and the floor that is consistent with moisture intrusion. The rate and quantity is undeterminable. Recommend monitoring area during a rain storm and correct grading, gutters, downspouts in area and further measures as needed.

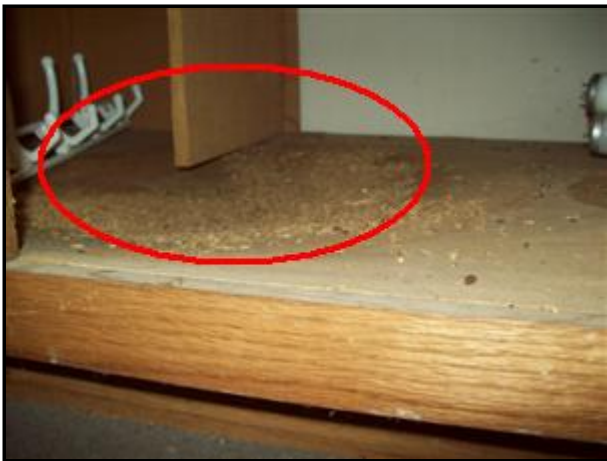
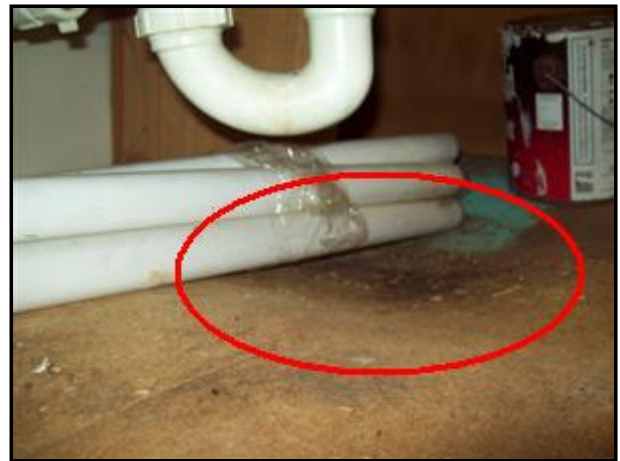
(Picture 1)(Picture 2) **EM** - The cabinet bottom piece is deteriorated from past water leaks. The cabinet has some microbial like growths present. No leaks were observed during our inspection. Recommend replacing cabinet as desired.

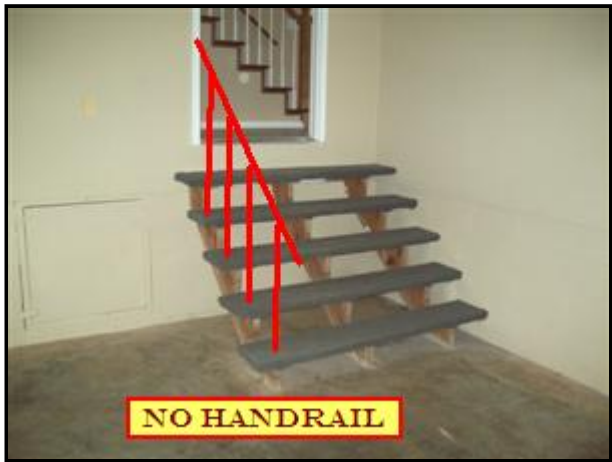
2.17 Picture 1

(Picture 1) **EM** - *garage, left side of home* - The steps to the home from the garage do not have a handrail and there are more than 4 risers. This was common construction when the home was built. Recommend adding a handrail with spindles spaced no farther than 4 inches as desired.

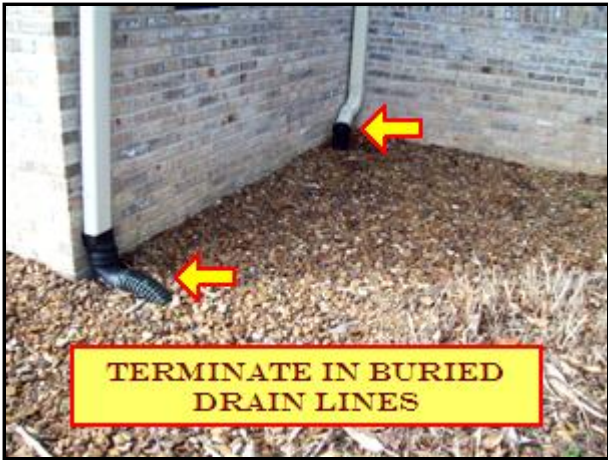
(Picture 1)(Picture 2) **FYI** - all corners of home - The downspout terminates into a buried drain line. I did not locate the termination point of all the drain lines. I'm unable to determine if they are clogged with debris or not. RECOMMENDATION: Monitor flow at the end of the drain lines during a rain storm or spray your roof with a hose to simulate a rain storm and clean/repair as and if needed.

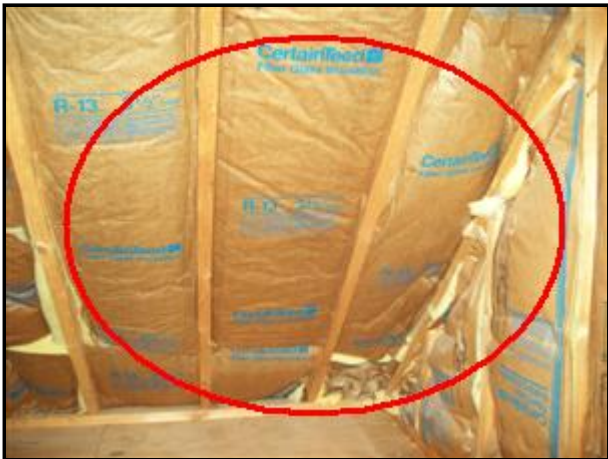
4.0 Picture 1

(1) (Picture 1) **EM** - *attic/storage closets* - The insulation along the rafters/wood sheathing is installed backwards or "upside down" which is common so people don't have to look at the insulation fibers. This can trap moisture in the insulation and transfer it to the joists plus the vapor barrier is flammable and manufacturer recommends on the label "not to leave exposed". Recommend replacing insulation with the vapor barrier against the wood sheathing.

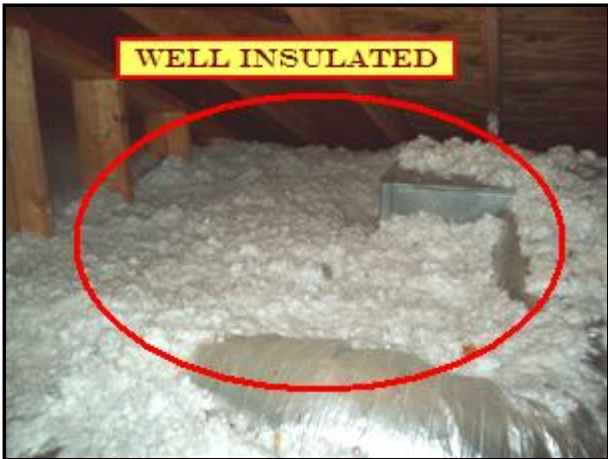
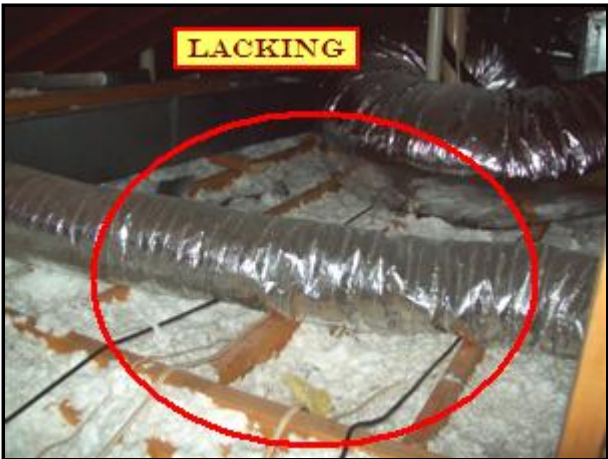
(2) (Picture 2)(Picture 3) **EM** - *attic space* - The Fiberglass insulation has been compressed in a couple of areas. This can allow cool or hot attic air to penetrate the sheetrock and increase heating or cooling costs. Recommend correcting as needed and desired.

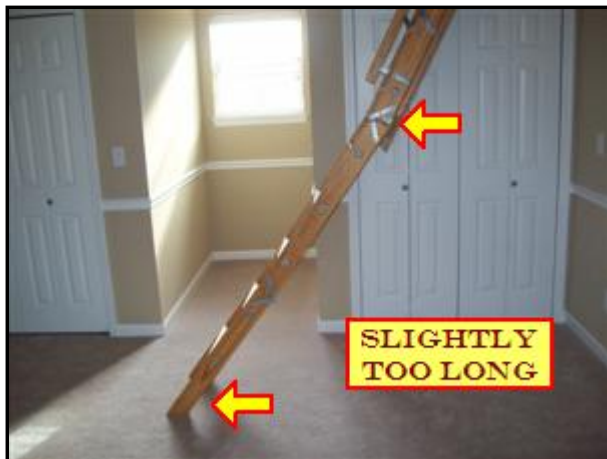
4.5 Picture 1

(Picture 1) **EM** - The attic pull down stairs are too long and don't sit properly on the floor. This could cause failure resulting in injury. Recommend trimming bottoms of stairs to meet manufacturer's requirements.

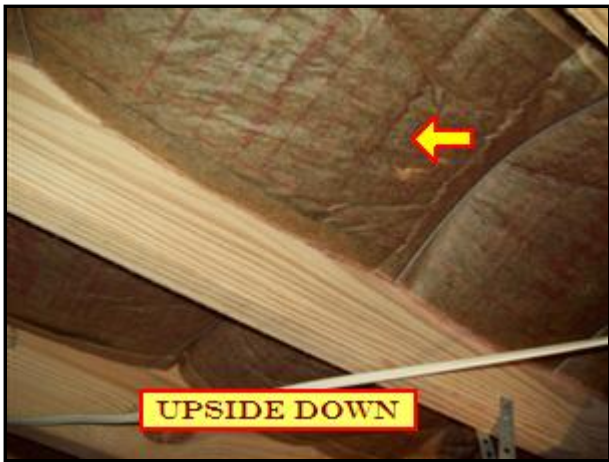
4.6 Picture 1

(Picture 1) **EM - crawlspace** - The insulation is installed upside down or with the vapor barrier facing down. The vapor barrier (paper) will burn and is supposed to be facing the "heated living space" or covered with appropriate material. There is a label on the insulation paper stating this.
RECOMMENDATION: Replace the insulation to manufacturer's specifications.

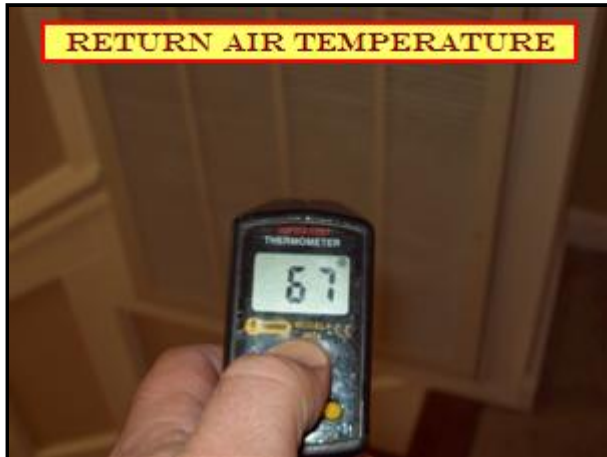
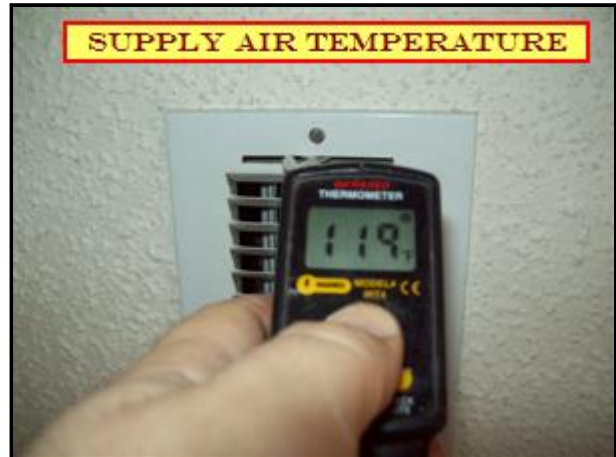
(1) (Picture 1)(Picture 2) **FYI** - An ambient air test was performed on the upstairs forced air furnace by using a digital thermometer to test the supply registers and a return vent to determine if there is a normal temperature rise. For gas type forced air furnaces, a temperature rise of 25 or more degrees is considered normal. The supply air temperature on your system read 119 degrees and the return air temperature was 67 degrees. This indicates the unit is heating the air within the normal range and only normal yearly servicing is required at this time.

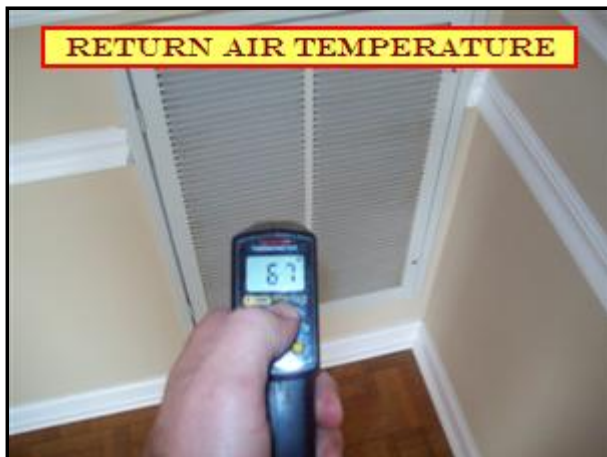
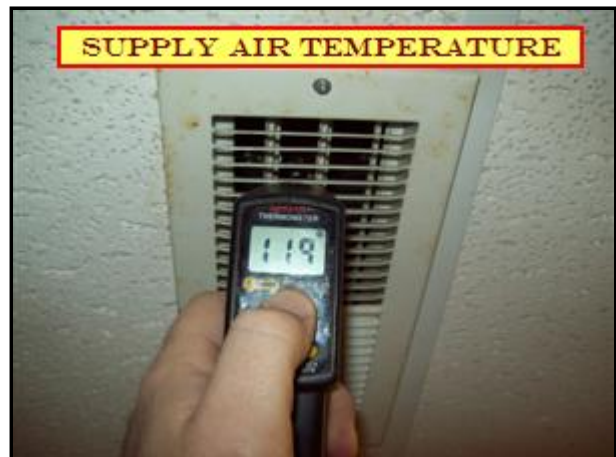
(2) (Picture 3)(Picture 4) **FYI** - An ambient air test was performed on the downstairs and basement forced air furnace by using a digital thermometer to test the supply registers and a return vent to determine if there is a normal temperature rise. For gas type forced air furnaces, a temperature rise of 25 or more degrees is considered normal. The supply air temperature on your system read 119 degrees and the return air temperature was 67 degrees. This indicates the unit is heating the air within the normal range and only normal yearly servicing is required at this time.

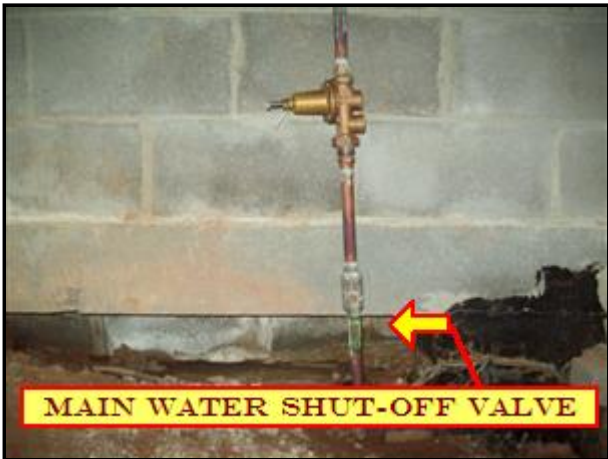
7.0 Picture 1

(Picture 1) **FYI** - The main water shut off valve is located in crawlspace by rear wall. This is just a picture to assist in the location.

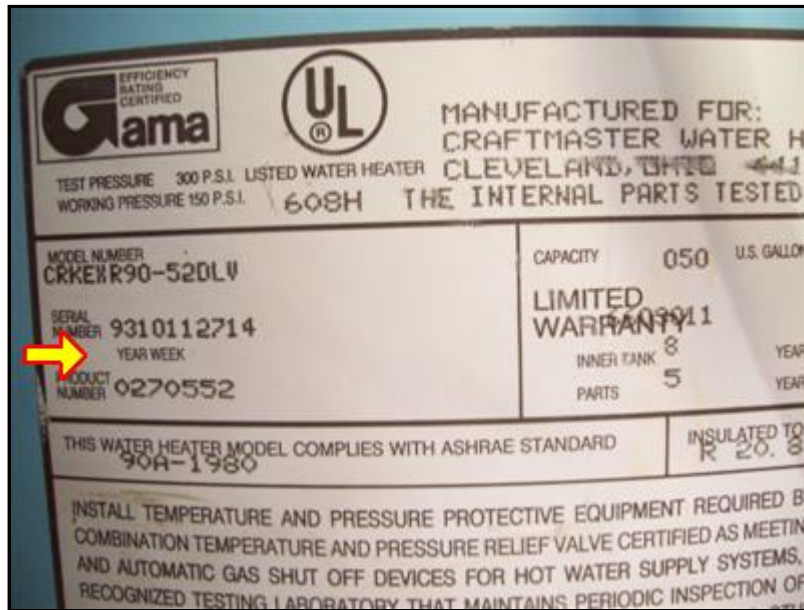
7.2 Picture 1

(Picture 1) **GC** - This is a picture of the manufacturer's label indicating useful information such as Serial # and Model #'s along with manufacturing date.

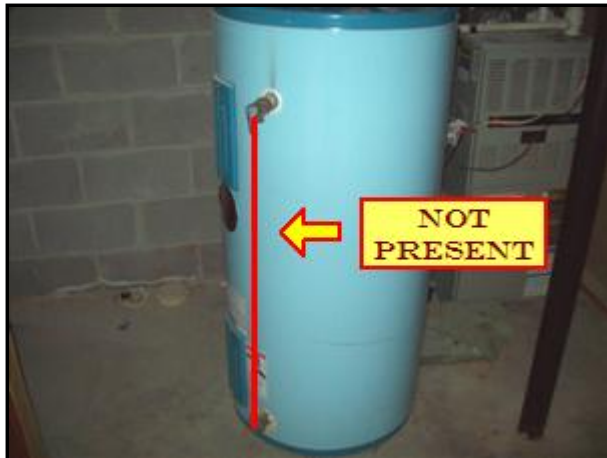
7.3 Picture 1

(Picture 1) **CA - Replacement** - *basement closet* - The extension piping for TPR (Temperature Pressure Release) valve is missing. When these devices trip, water coming out of this pipe will be a combination of water and steam that is over 200 degrees Fahrenheit (immediate 3rd degree burn). The water coming out if tripped is over 200 degrees Fahrenheit which can cause serious burns. Recommend correcting as needed and desired.

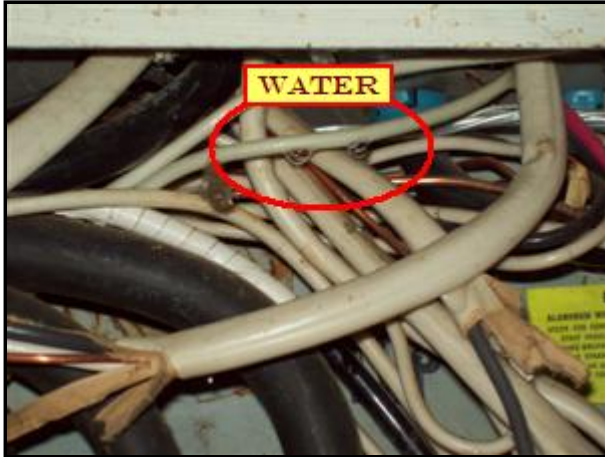
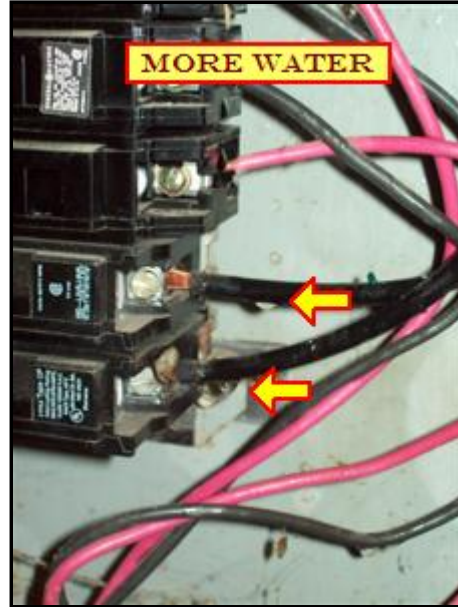
(2) (Picture 1)(Picture 2)(Picture 3)(Picture 4) **CA - Repair** - garage right side of home - There was one or more defects or safety hazards observed in the main panel consisting of Pointed screws holding dead front on (should be blunt ended), water located in panel and on wiring and one 15 AMP breaker that keeps tripping. NOTE: Electrical panel covers should NEVER be removed by un-qualified persons due to the seriousness of life threatening hazards present. Recommend having a licensed electrician evaluate the entire panel further and repair/replace as needed.

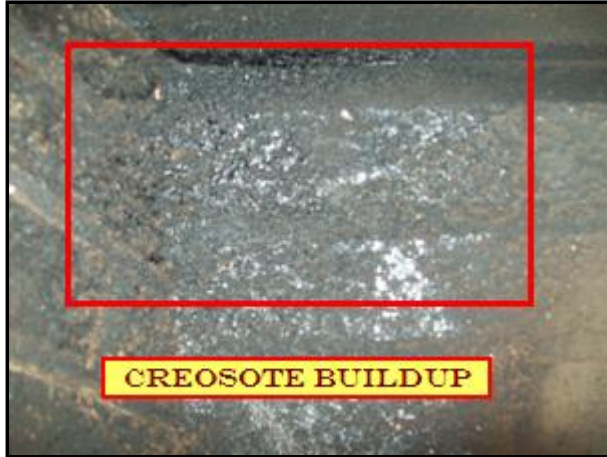
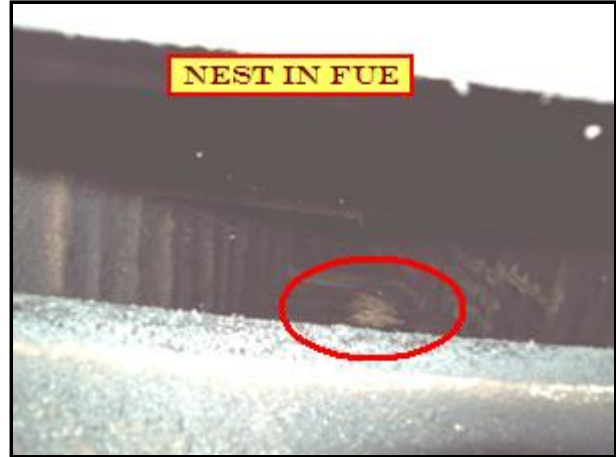
(Picture 1)(Picture 2) **NM** - *living room* - The smoke chamber and flue was covered in Creosote. This material is flammable and the cause of most chimney fires. Chimney's should be cleaned in accordance with how much they are used, usually after 150 burnings. This chimney doesn't appear to have been cleaned in several years. There also appears to be a nest of some animals in the smoke chamber. Recommend having a qualified chimney sweep clean the chimney and then perform a level 2 inspection, correcting as needed and desired.

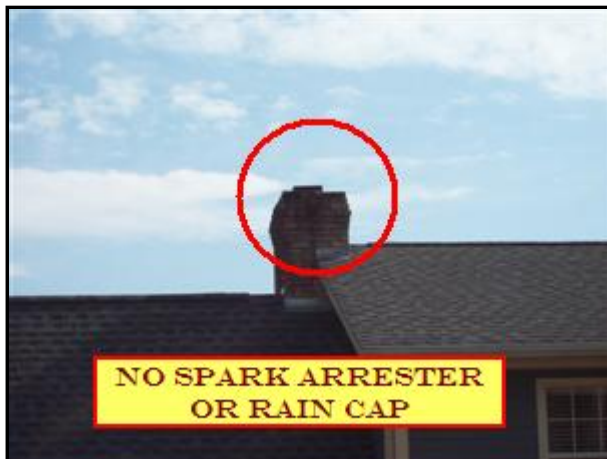
9.1 Picture 1

(Picture 1) **EM** - *top of chimney* The top of the flue is missing a rain cap/spark arrester. This can allow rain, birds, squirrels and other vermin into the flue of the chimney. A screen (spark arrester) will prevent large sparks from blowing out of the chimney. Recommend installing a spark arrester/rain cap over all openings as needed and desired.

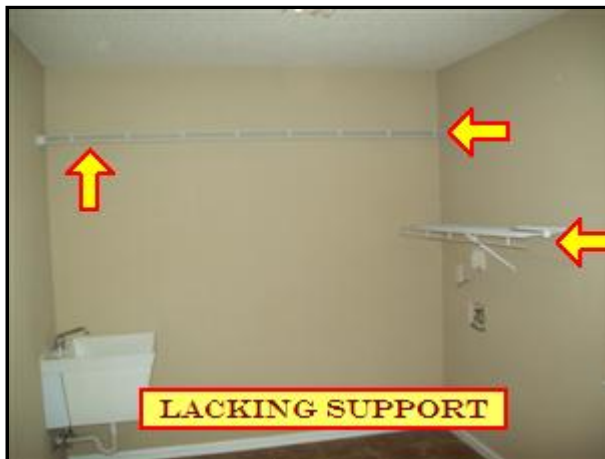
10.1 Picture 1

(Picture 1) **FYI** - The shelves in the laundry room are installed where they will hold much weight. Recommend adding support brackets before placing stuff on shelves.

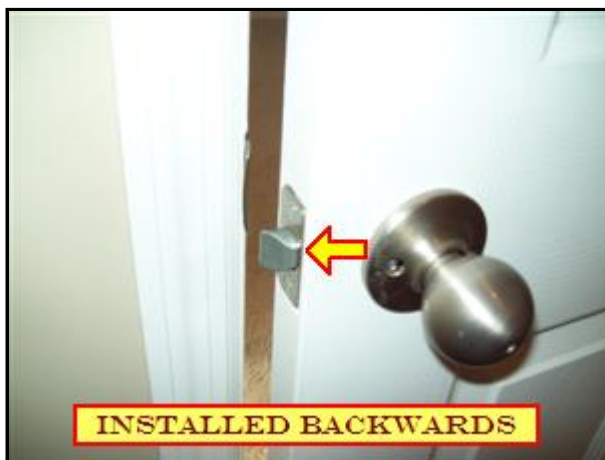
10.4 Picture 1

(Picture 1) **EM** - *office entry door from hall* - The latching hardware is installed backwards. Door doesn't latch unless the handle is turned. Recommend correcting as needed.

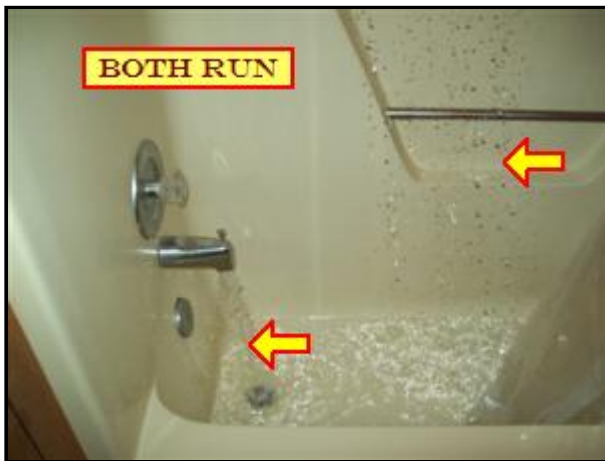
11.2.E Picture 1

(2) (Picture 1) **EM** - The shower diverter valve has gone bad. This will waste water while taking a shower. Recommend replacing as needed and desired.

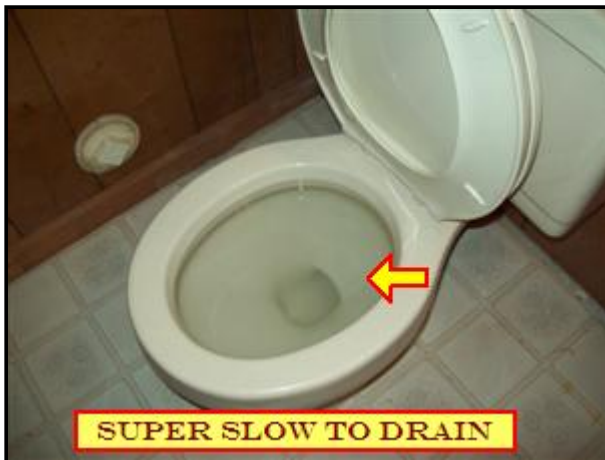
11.4.E Picture 1

(2) (Picture 1) **NM** - The toilet when flushed did not remove the water in the bowl. This is most likely a clog in the line or back of the bowl somewhere. Recommend plunging the toilet to see if you break it loose or call a plumber.

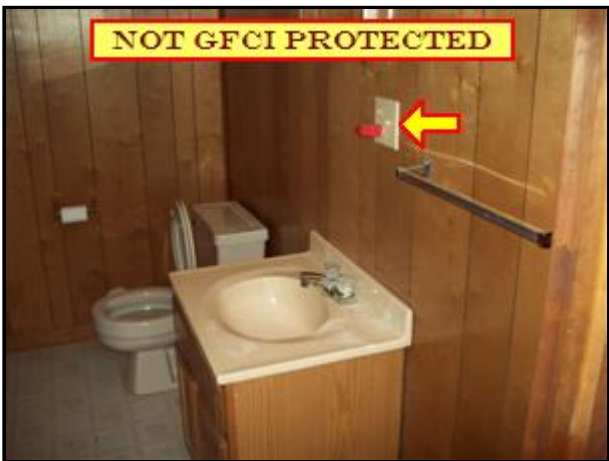
11.6.E Picture 1

(Picture 1) **CA - Safety Concern** - There is no GFCI present. The rest of the bathrooms have this protection making this a deficiency. Recommend installing as needed.

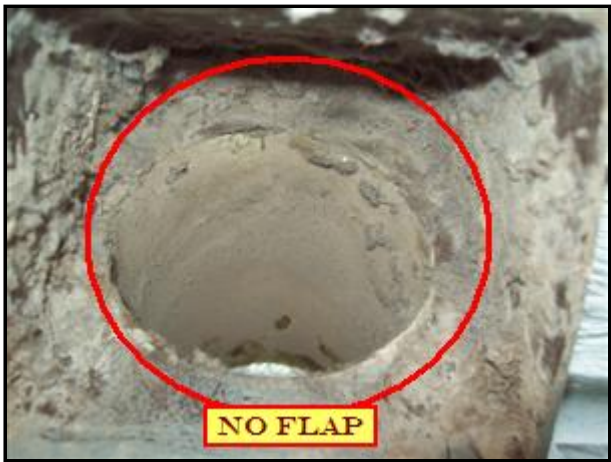
12.15 Picture 1

(Picture 1) **EM** - rear of home - There is no cover flap on the outside of the home. Vermin can enter the dryer as is. Recommend installing cover as needed.

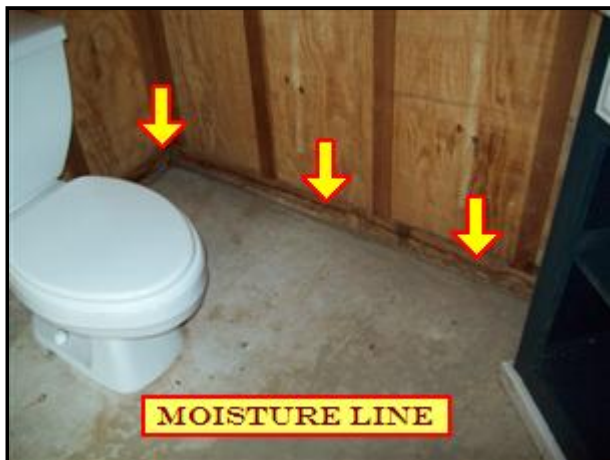
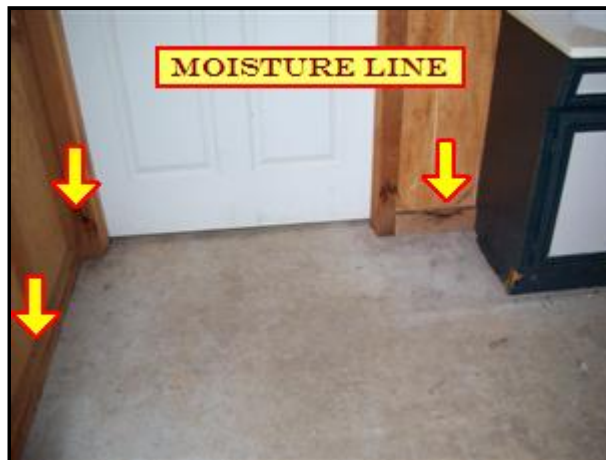
(Picture 1)(Picture 2) **NM** - There is a moisture line along the floor boards. This most likely is from water of the pool room next to it (back flushing, valves, etc...) Wet wood is conducive to Termite activity. Recommend monitoring water levels in building and correcting as needed.
